**Docket No. 217 – Development and Management Plan Inspection**

Northeast Utilities Service Company Certificate of Environmental Compatibility and Public Need for the construction of a 345-kV electric transmission line and reconstruction of an existing 115-kV electric transmission line between Connecticut Light and Power Company's Plumtree Substation in Bethel, through the towns of Redding, Weston, and Wilton, and to the Norwalk Substation in Norwalk, Connecticut.

**Date:** October 27, 2005

**Location:** 115 kV Underground Route

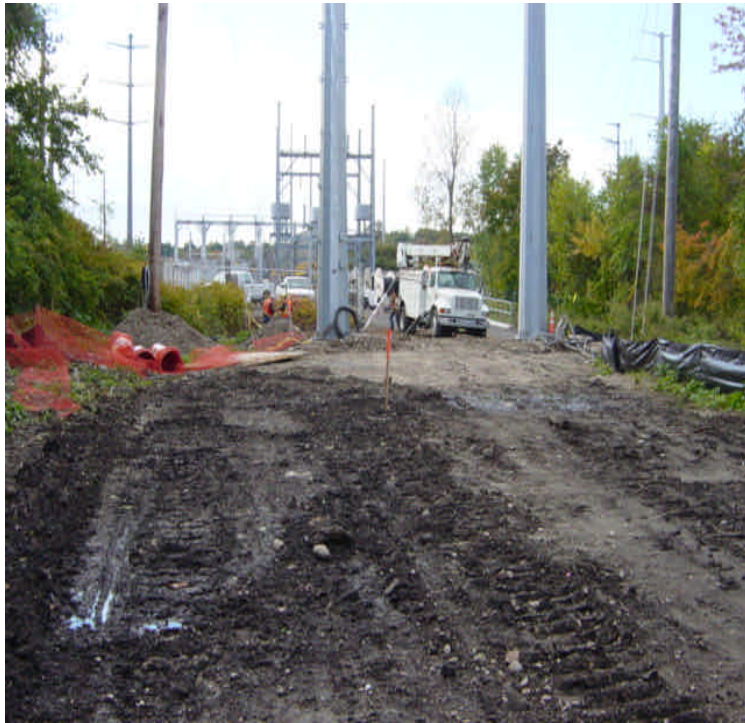
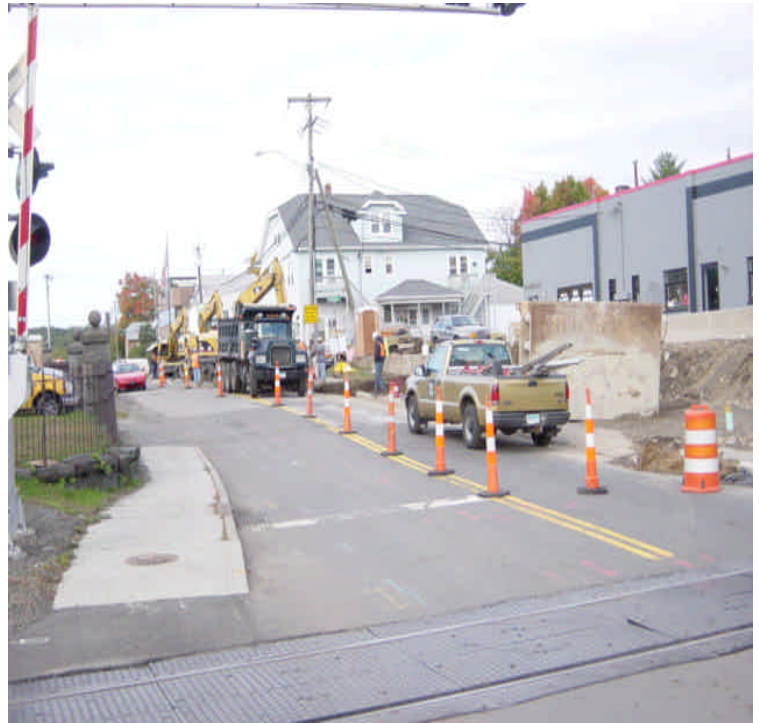
**115kV (Broad Street and ROW):** The photo on the left shows the ROW which was muddy following the rains but remains contained. Photo on the right shows the continuing operation at the railroad jack and bore. Trenching is continuing to Rt. 7. 10/27/05

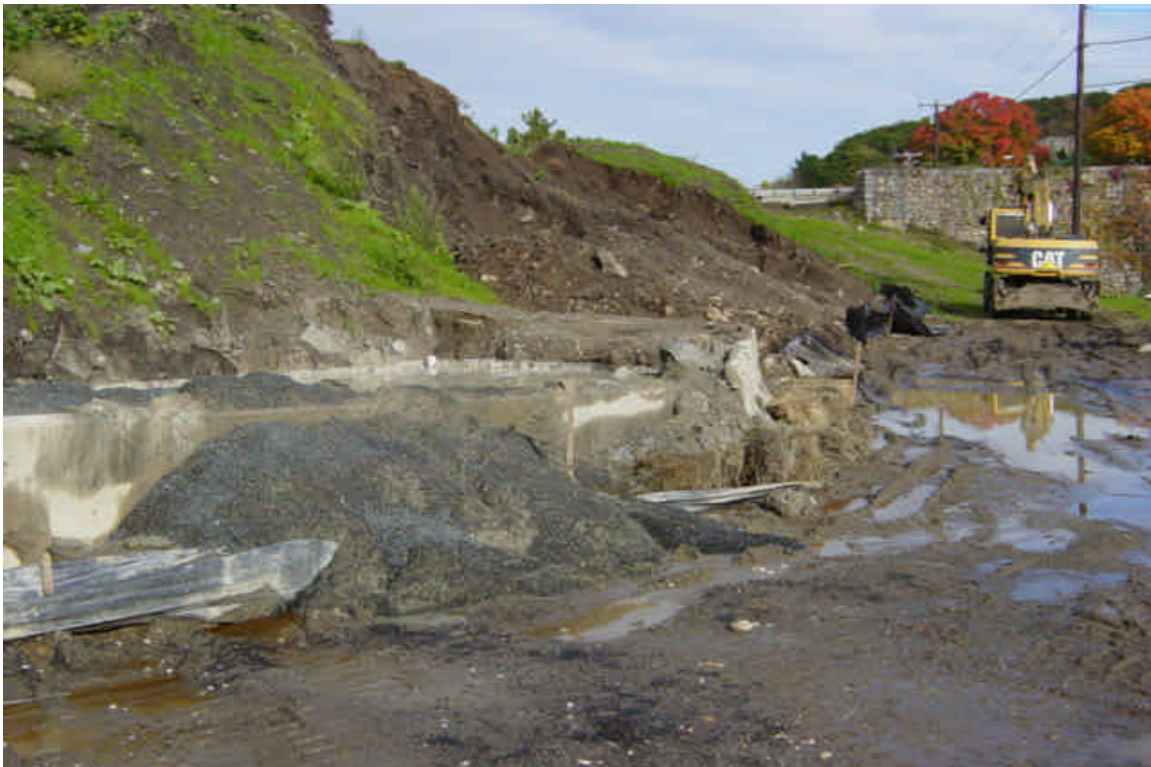
**115kV (Route 7):** View of the Merritt cloverleaf concrete washout with controls in disrepair and with concrete outside of the corral area. This area looks worse than it has in recent weeks. 10/27/05

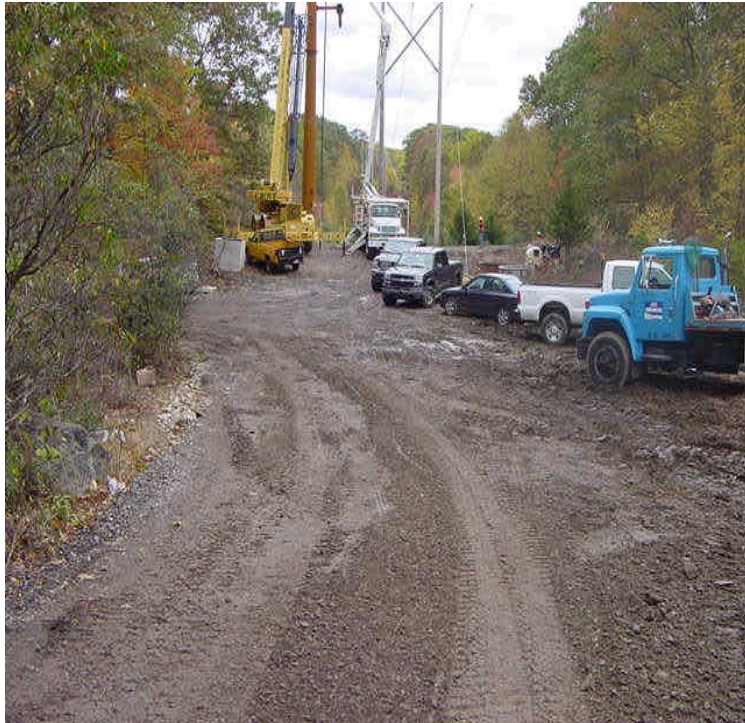
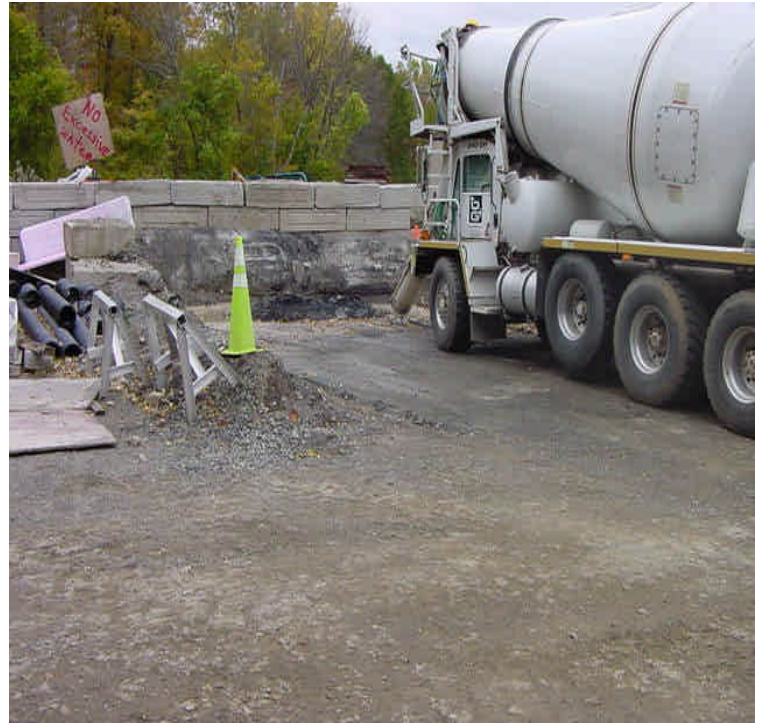
**115kV: Photo on the left shows cable pulling from Gallows Hill Road up to the transition structure on the ROW. Photo on the right shows good use of the concrete washout at the Redding Town Yard. 10/27/05**

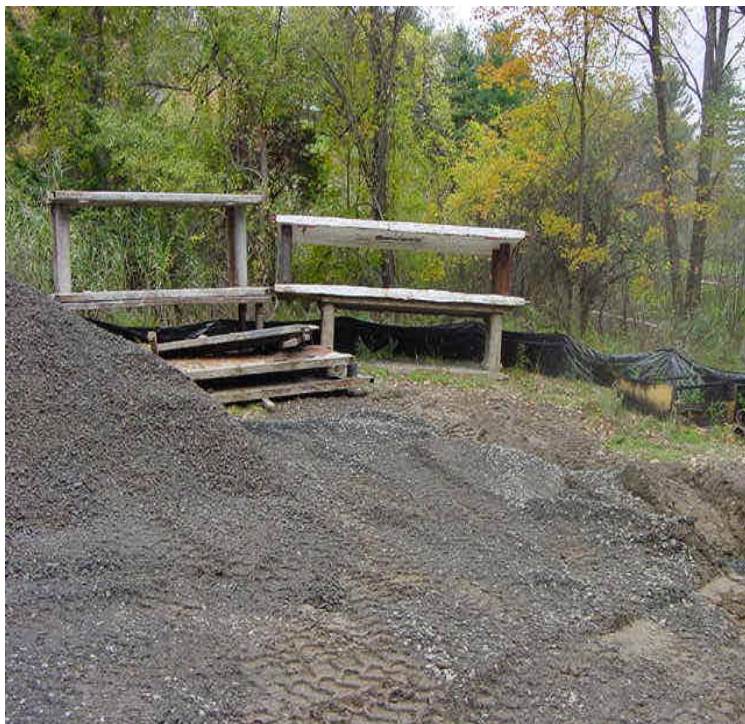
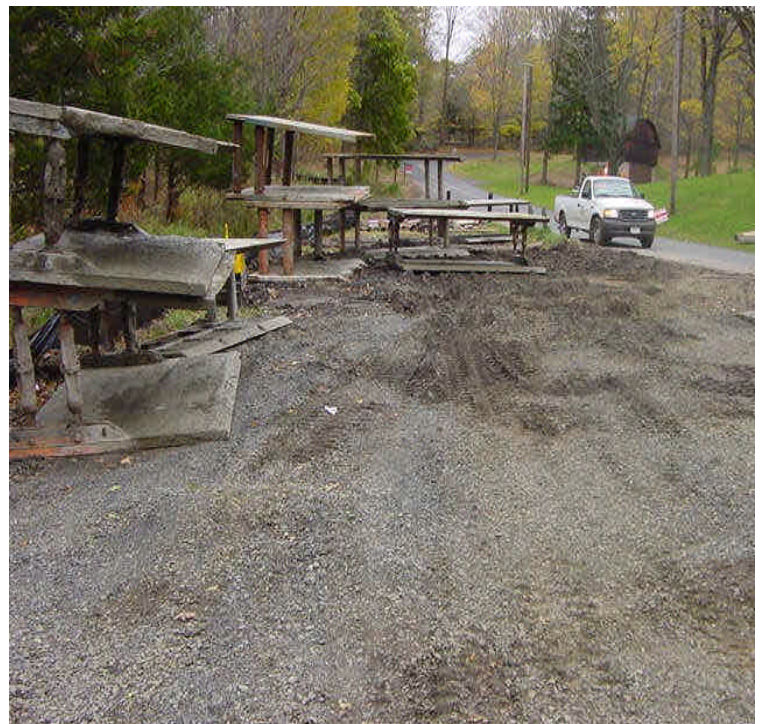
**115kV (Rts 107 and 58). Photo on the left is of the Redding Country Club area with stonepiles and trenchboxes stored here. Photo on the right is of the Sunset Hill Rd. storage area. 10/27/05**

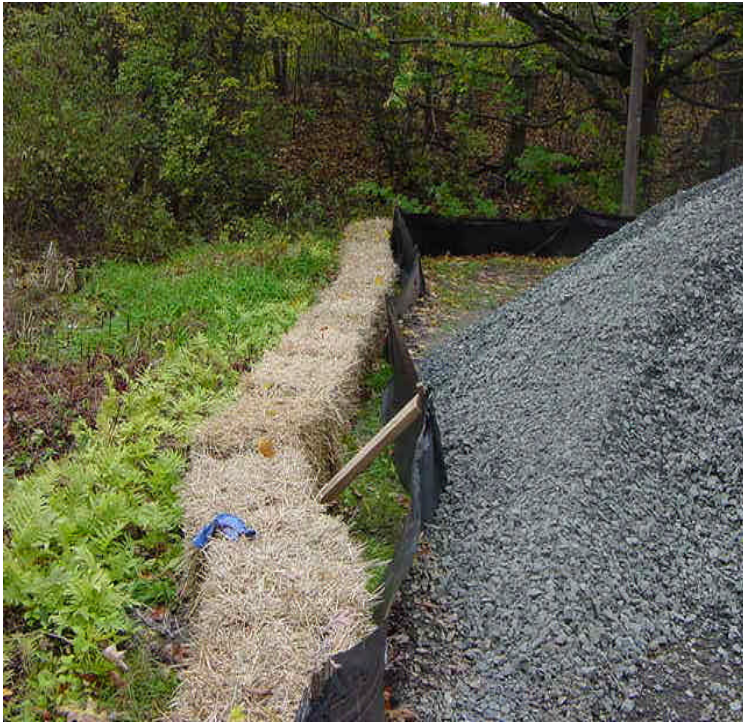
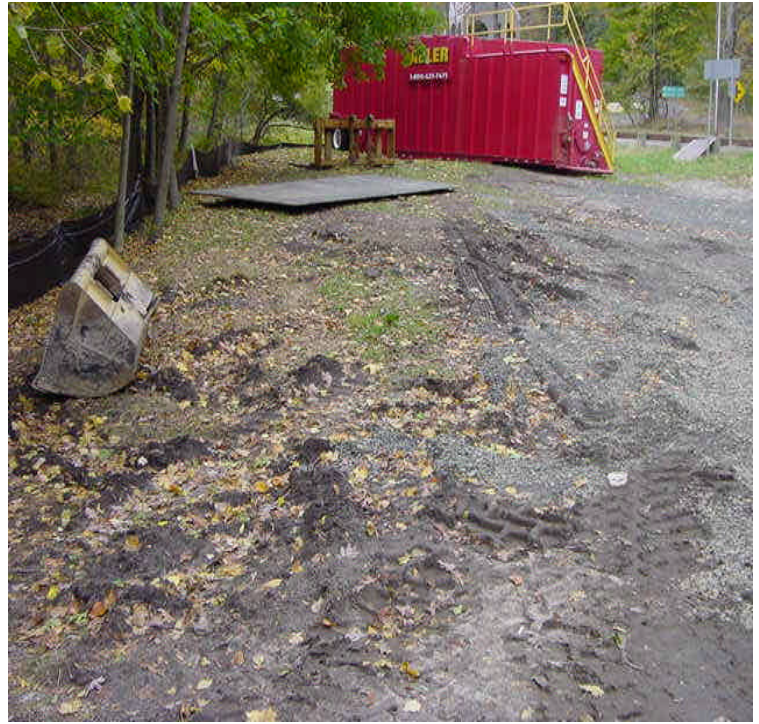
**115kV: (Rt. 58 ) Photo on the left shows haybales installed as an additional barrier at the pond's edge at the Putnam Park storage area. Photo on the right shows an overview of the same yard with few materials left here. 10/27/05**

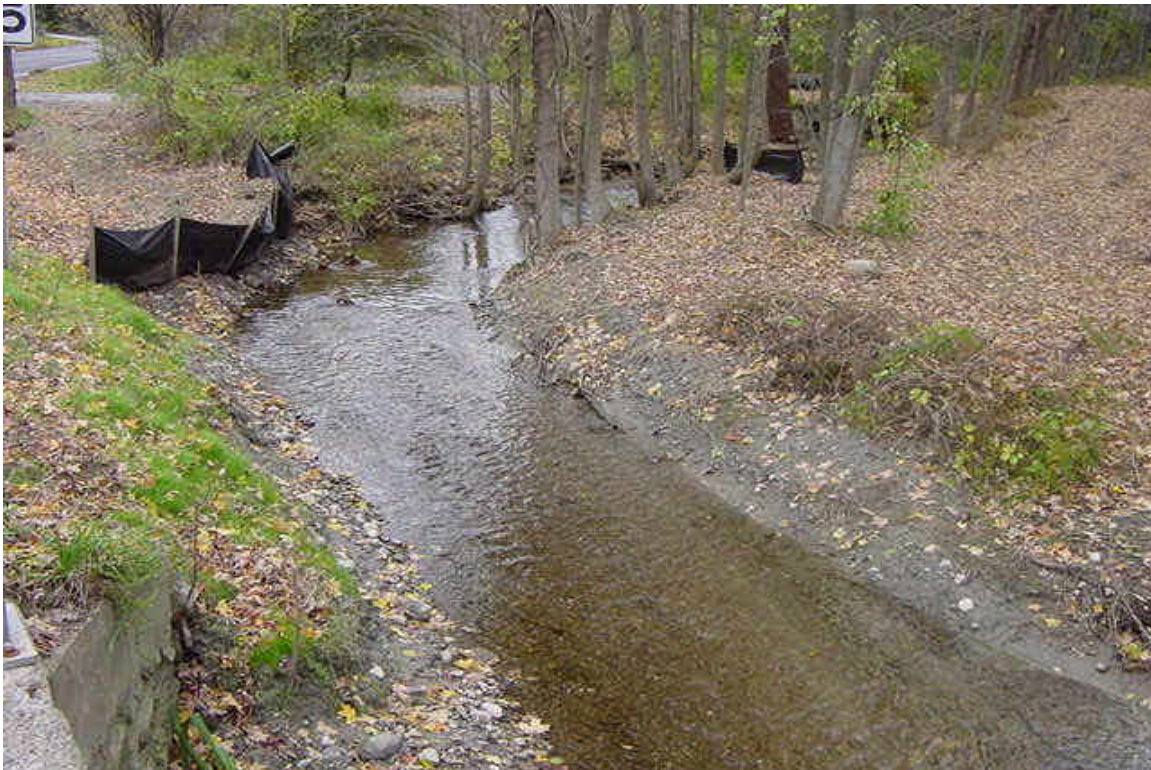
**115kV: (Rt. 58/Sara's Way). Additional view of the stream at Sara's Way with clear water quality and good flow returned to the channel. 10/27/05**

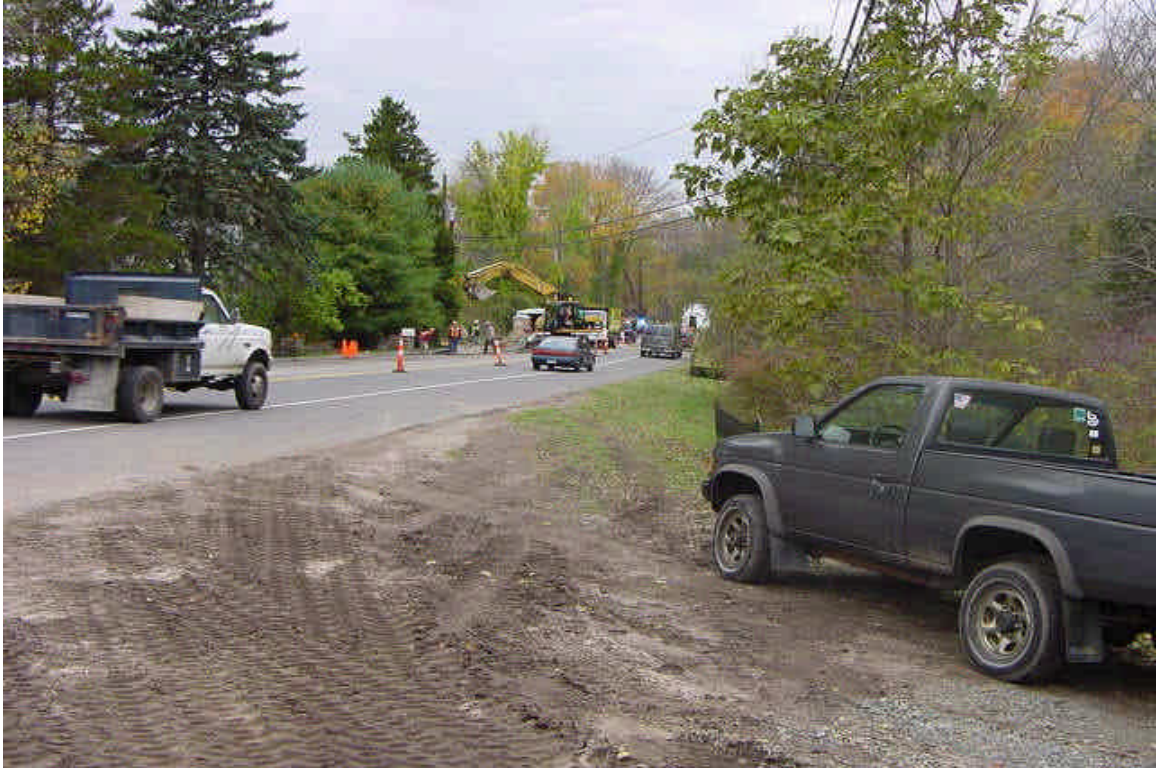
**115kV (Rt. 58): View of roadway work ongoing along Rt. 58 near Sunset Hill Rd. (10/27/05)**

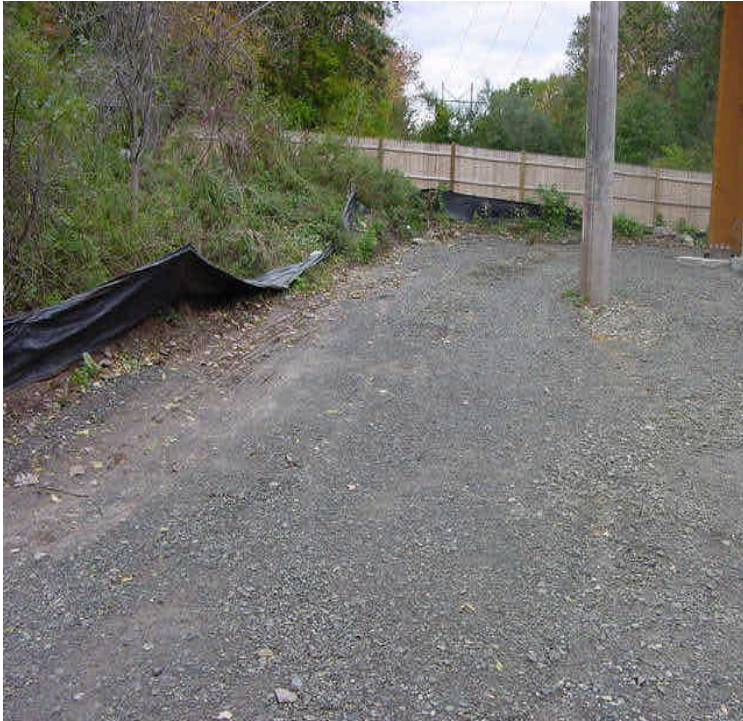
**115kV: Photo on the left shows the base of the transition structure installed at Hoyts Hill Rd. Silt fence can be removed from the upgradient side of the site. The photo on the right shows an erosive gully along the southern portion of the ROW where the washout is beginning to overwhelm the fence. 10/27/05**

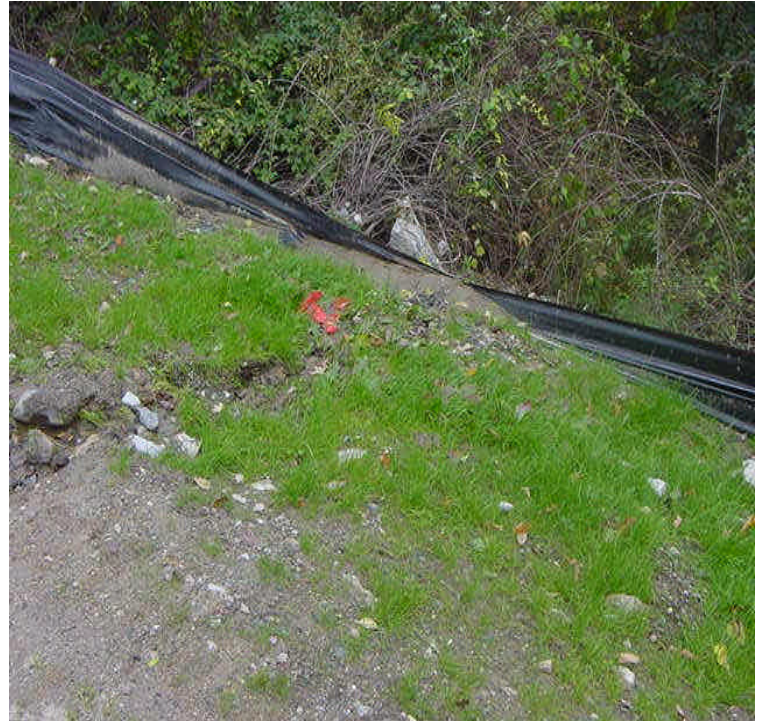
Areas of Inspection	Observation	Recommended Action
<b>Bethel Educational Park</b>	- The gully noted on the northern part of the ROW has washed out again despite repairs. 10/27/05 - A small washout was also noted along the southern ROW. 10/27/05 -Silt fence was in good shape in all locations. The slope at the southern end of the ROW remains stable at this time. 10/27/05	-Stone can be installed here as a potential solution to the run-off. 10/27/05 - Continue to monitor. 10/27/05  - If necessary, place mulch and seed or less preferable, stone along the slope to further stabilize. 10/27/05
	-The transition structure has been installed here. Erosion controls can be removed around the upgradient portion but should remain at the low points. 10/27/05	- Remove upgradient erosion controls when convenient. Equipment will return here for some cable work. 10/27/05
<b>Hoyts Hill Riser Transition Structure (Off Rt. 58)</b>
